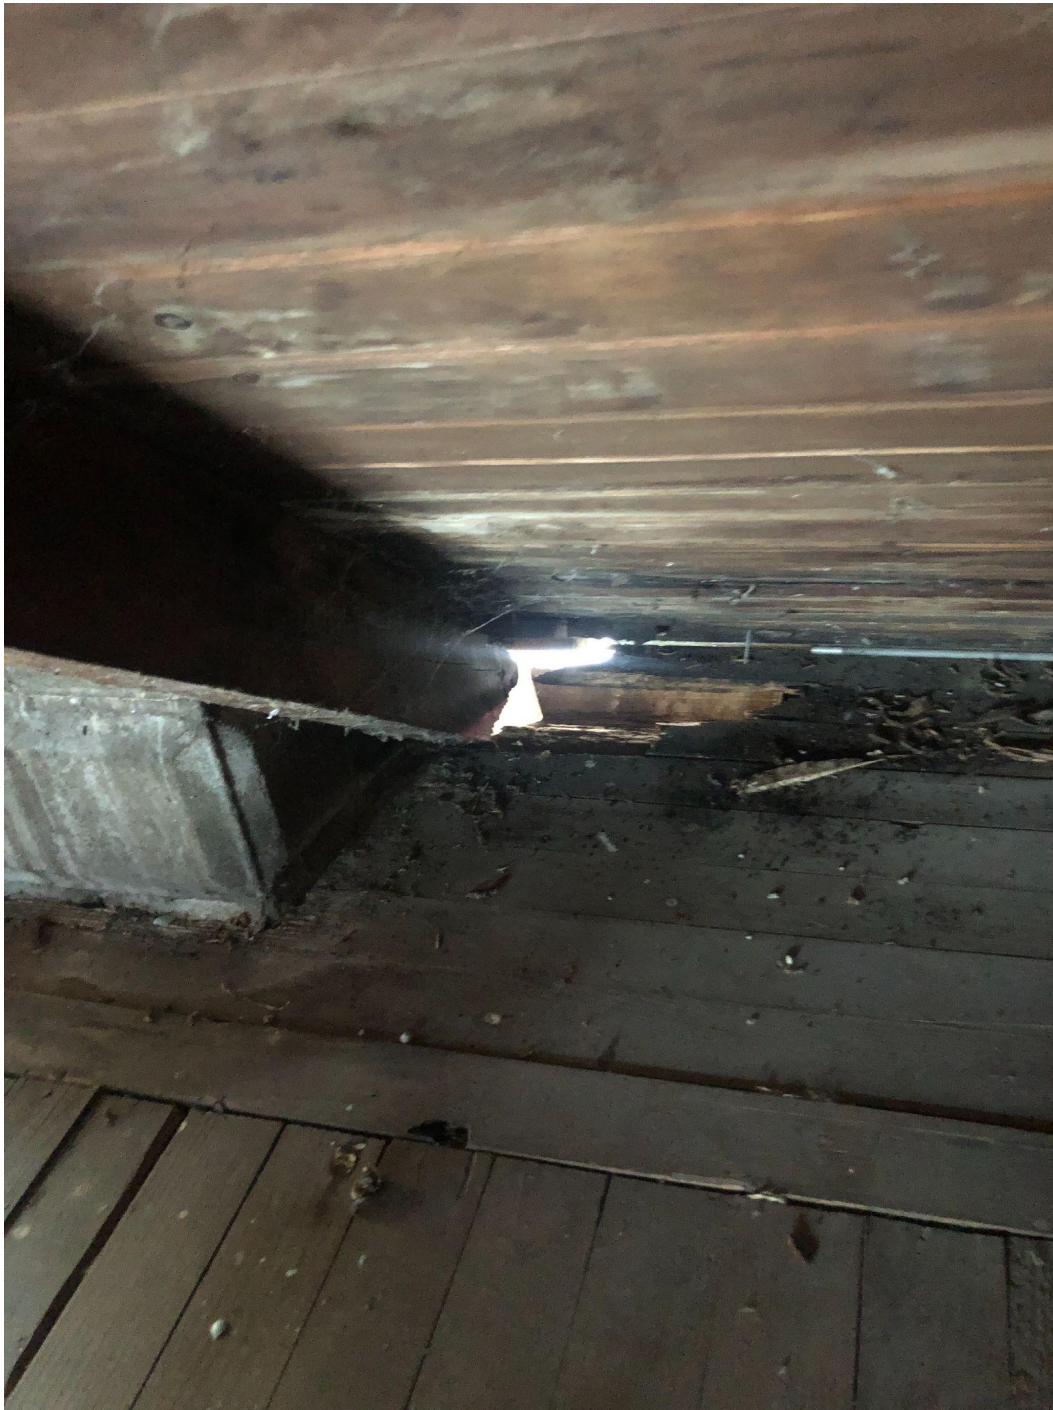
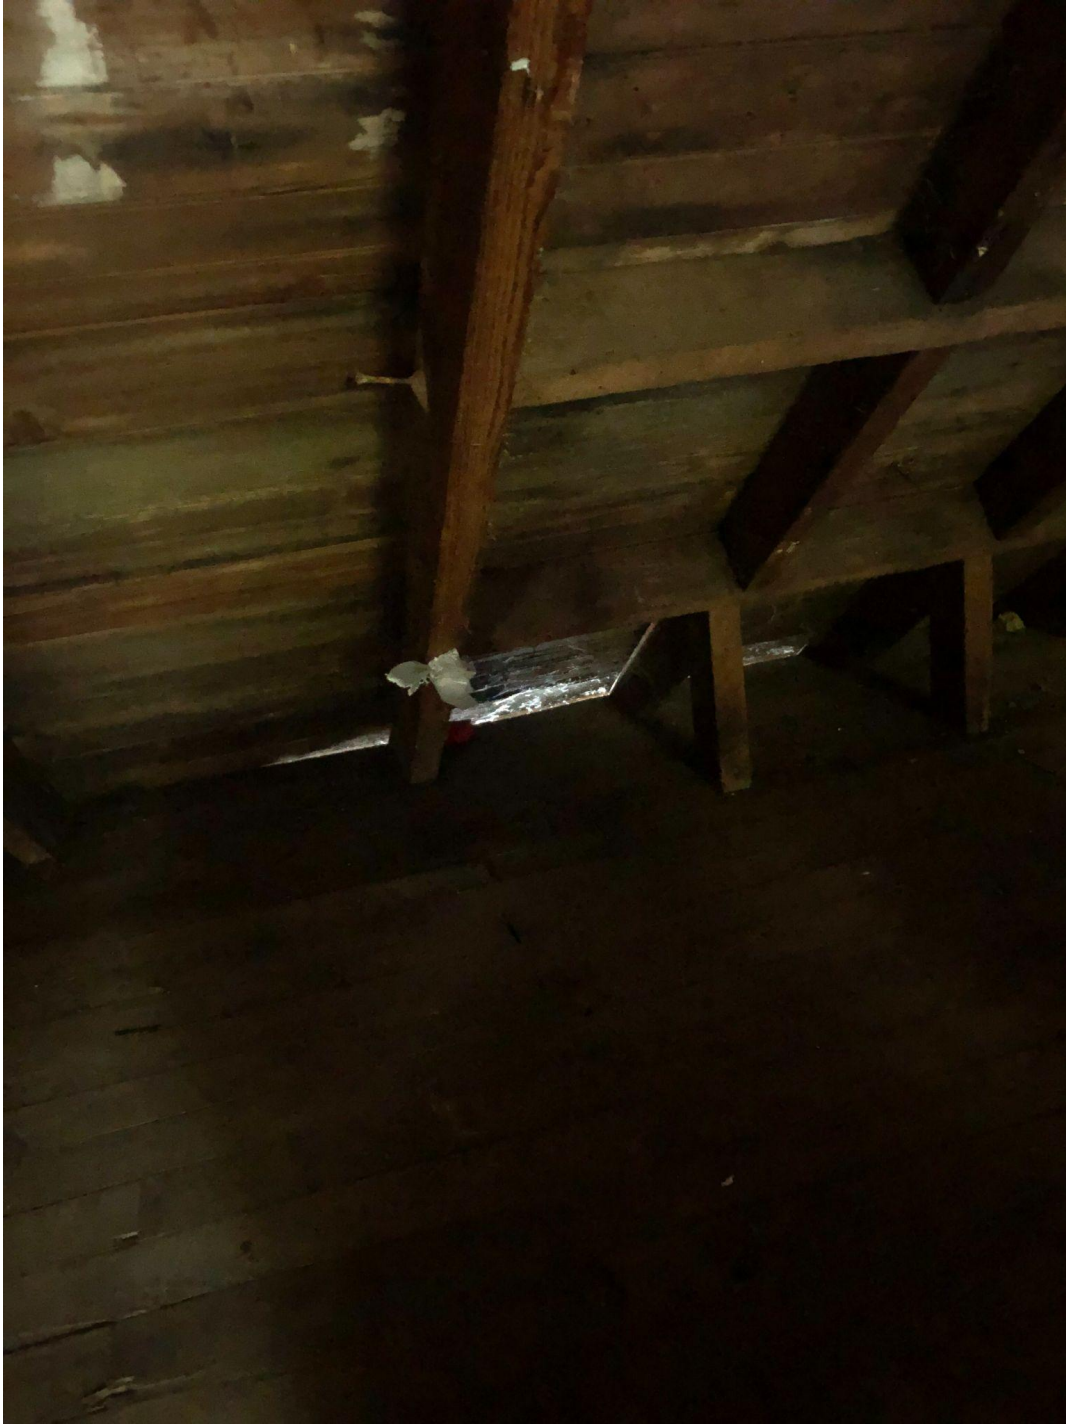
This damage is on the fascia board on the eastern side of the structure, approximately where the gutter attaches and around the chimney. This is on the attic level(third floor)

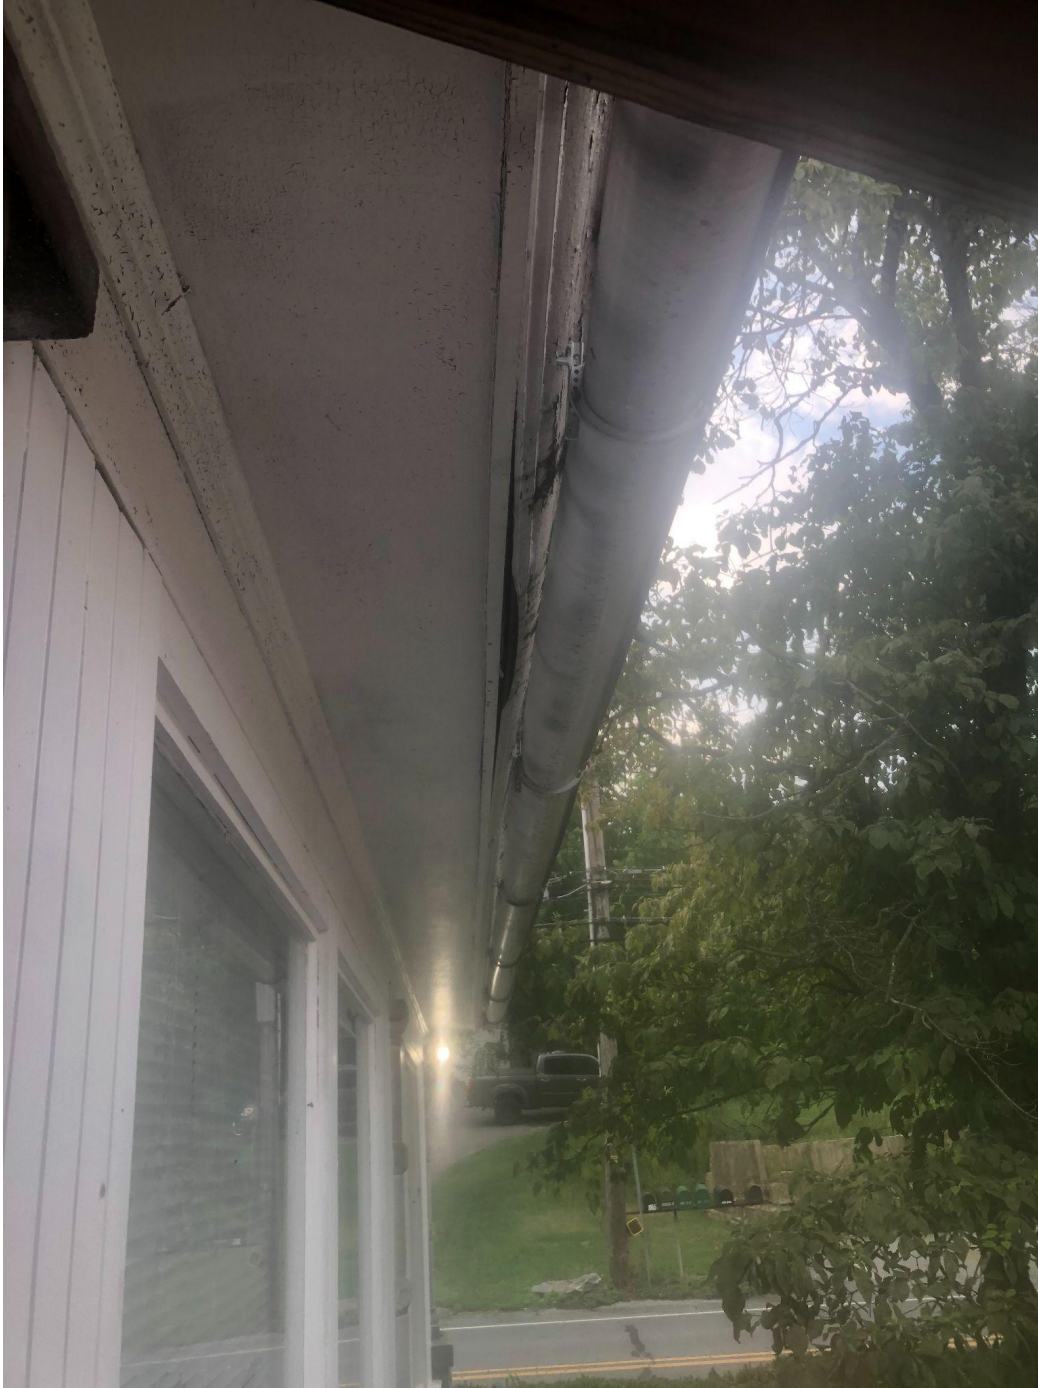
This damage is on the front fascia board, approximately where the gutter attaches. This is on the attic level(third floor).
